COMMONWEALTH OF MASSACHUSETTS
OFFICE OF CONSUMER AFFAIRS AND BUSINESS REGULATION
DEPARTMENT OF
TELECOMMUNICATIONS & ENERGY
PIPELINE ENGINEERING AND SAFETY DIVISION

INCIDENT REPORT

65 Main Street, Hopkinton, Massachusetts
July 24, 2002

Date of Issue: November 6, 2003

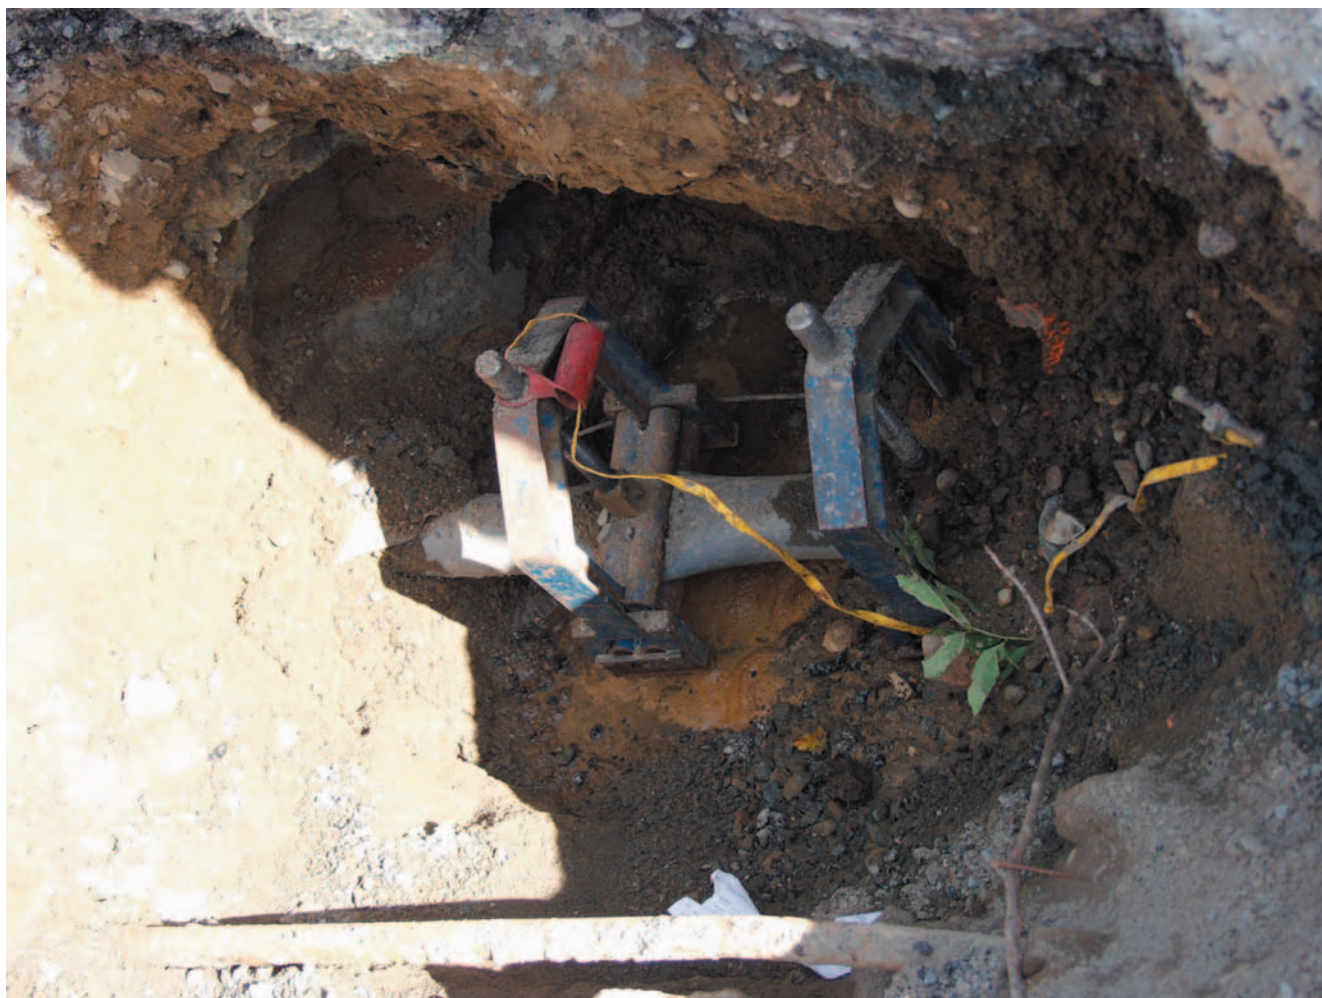
6

Photograph of squeeze-off tool installed in
the easterly excavation Main Street,
Hopkinton
July 24, 2002

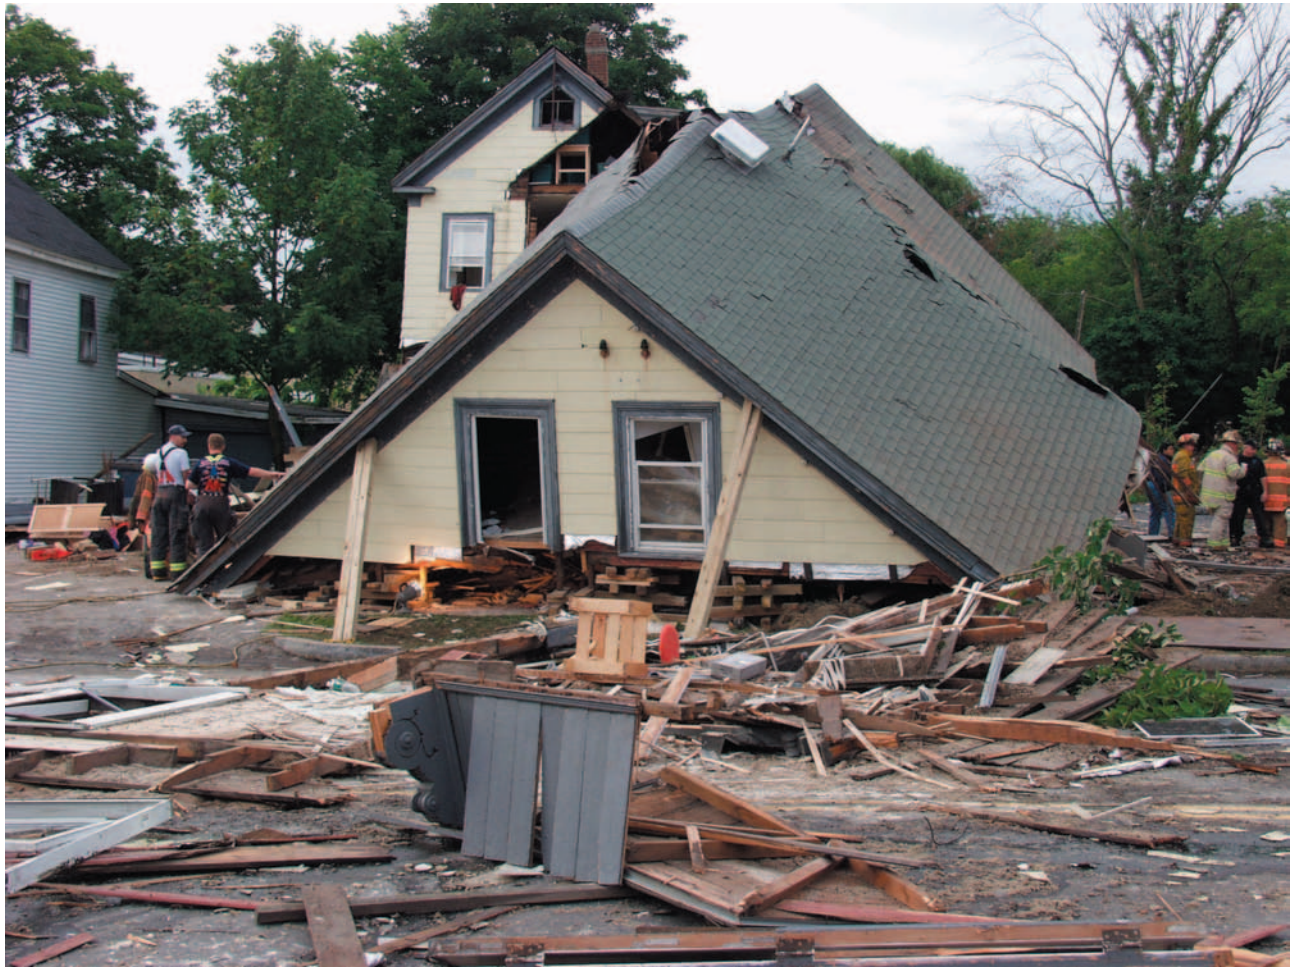
Exhibit 14

Photograph of collapsed house at 65 Main
Street, Hopkinton
July 24, 2002

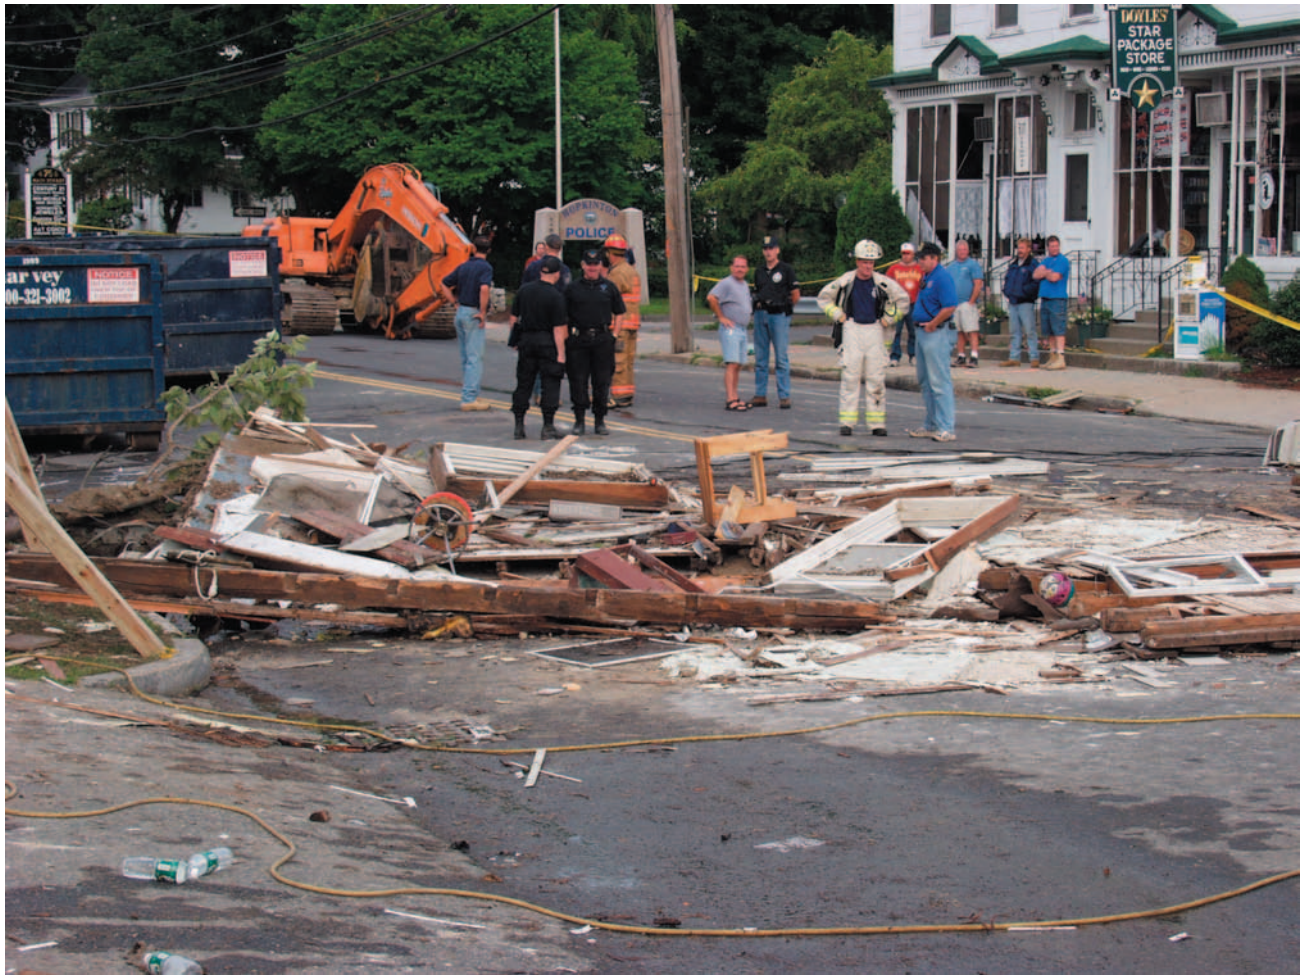
Exhibit 15

Photograph of debris in front of 65 Main
Street, Hopkinton
July 24, 2002

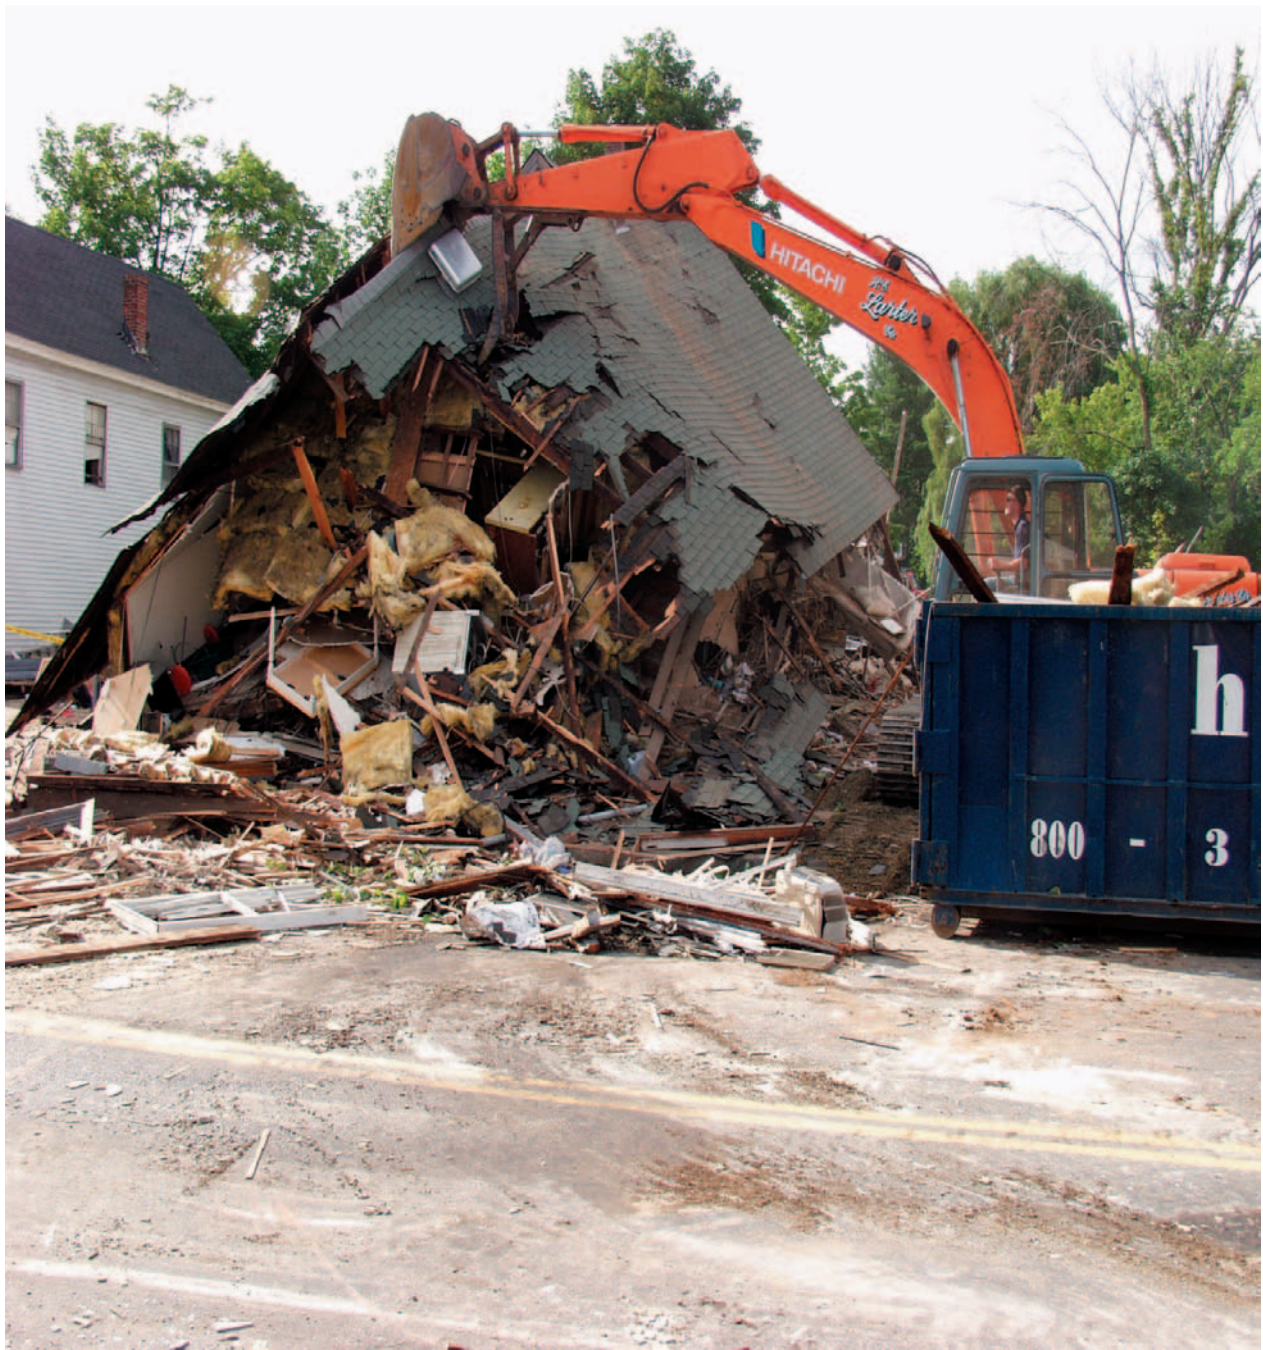
**Exhibit
16**

Demolition of the house at 65 Main Street,
Hopkinton
July 24, 2002

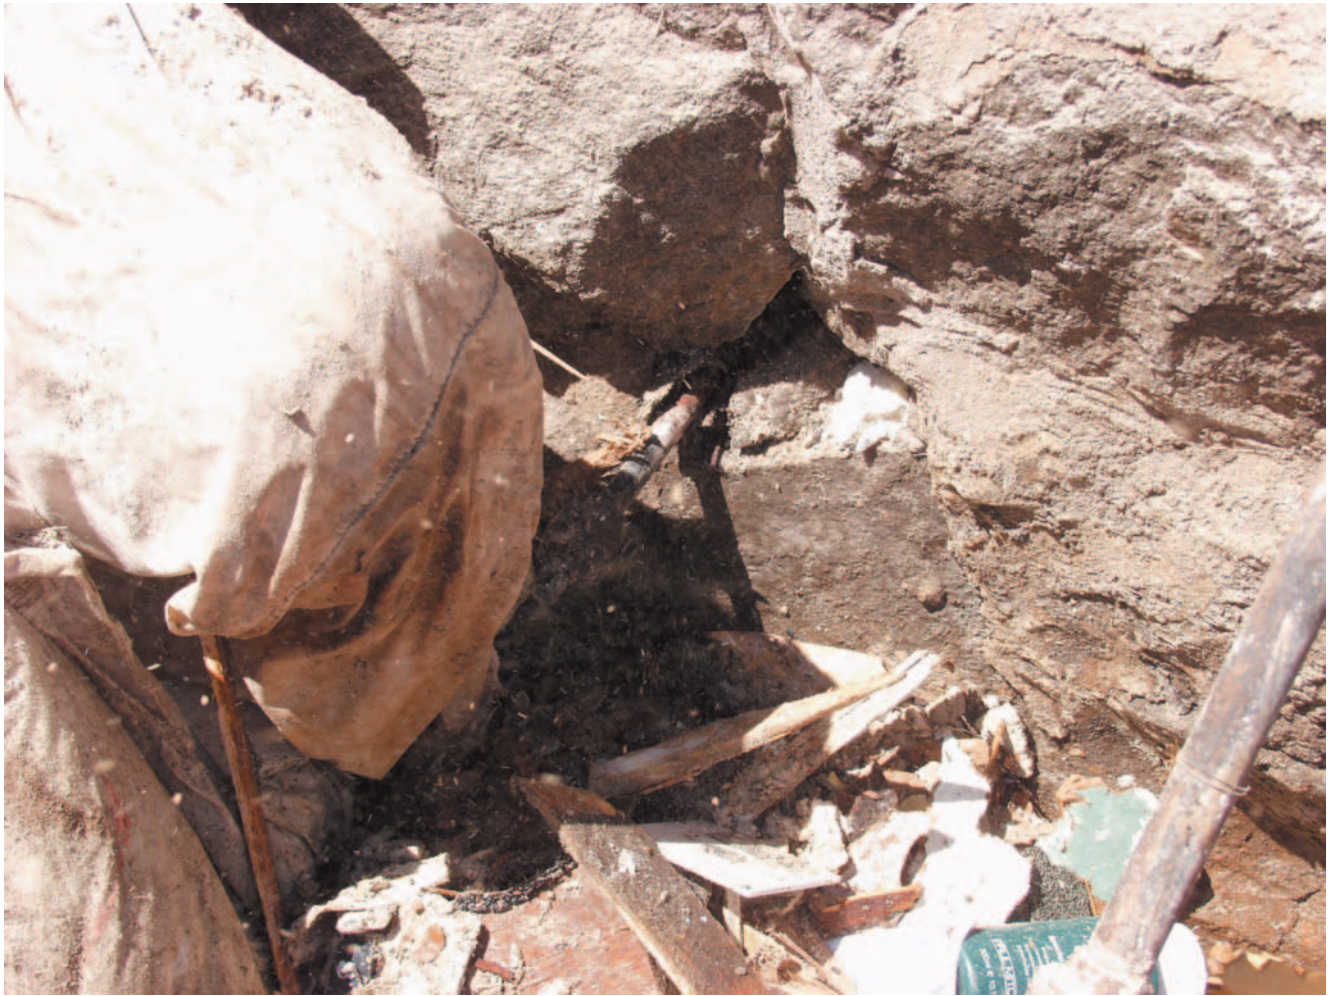
Exhibit 17

Service line penetration through basement
wall

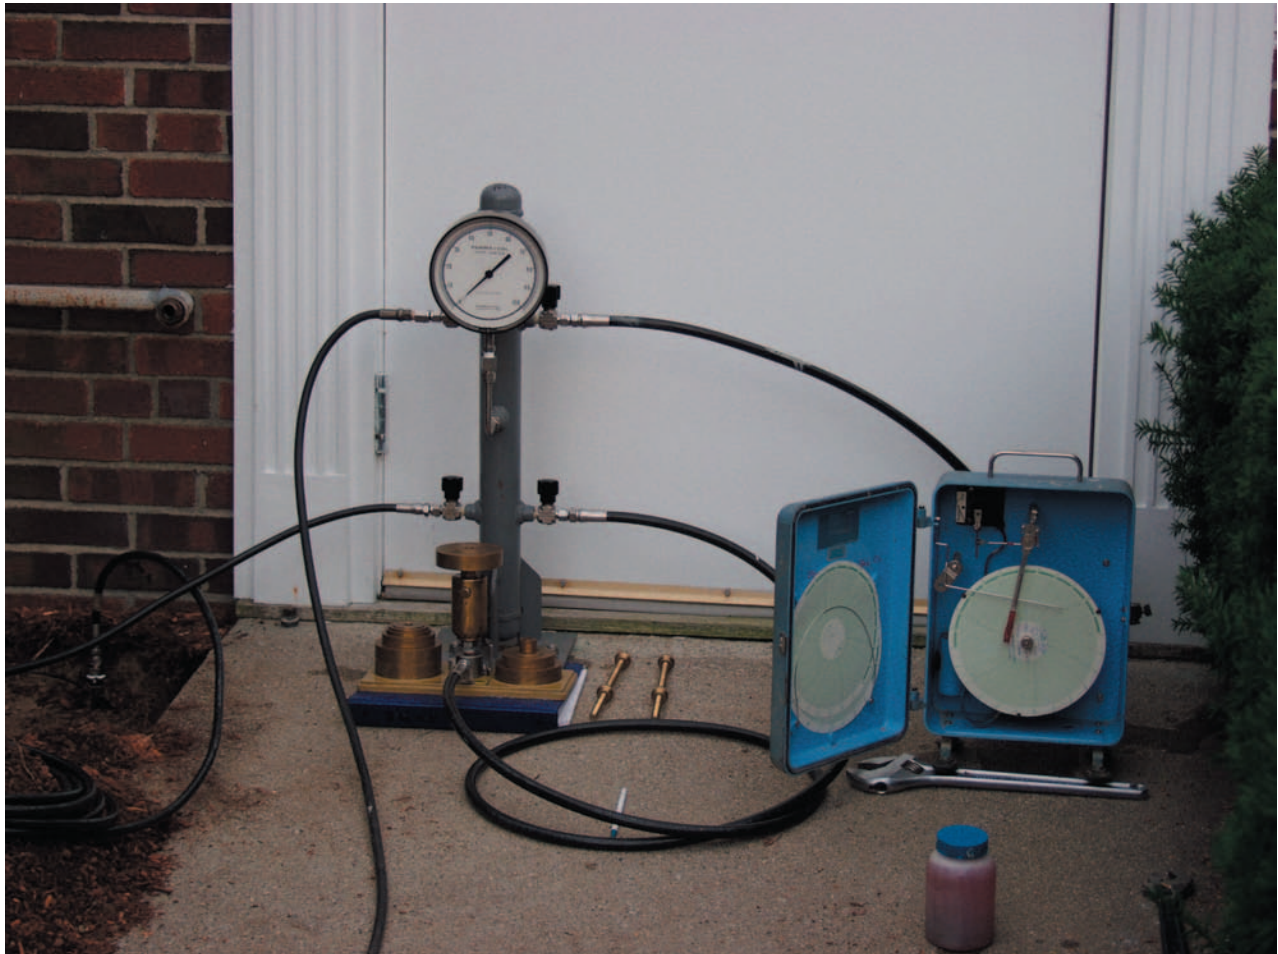
**Exhibit
18**

Photograph of dead weight tester set up
behind 66 Main Street, Hopkinton
July 24, 2002

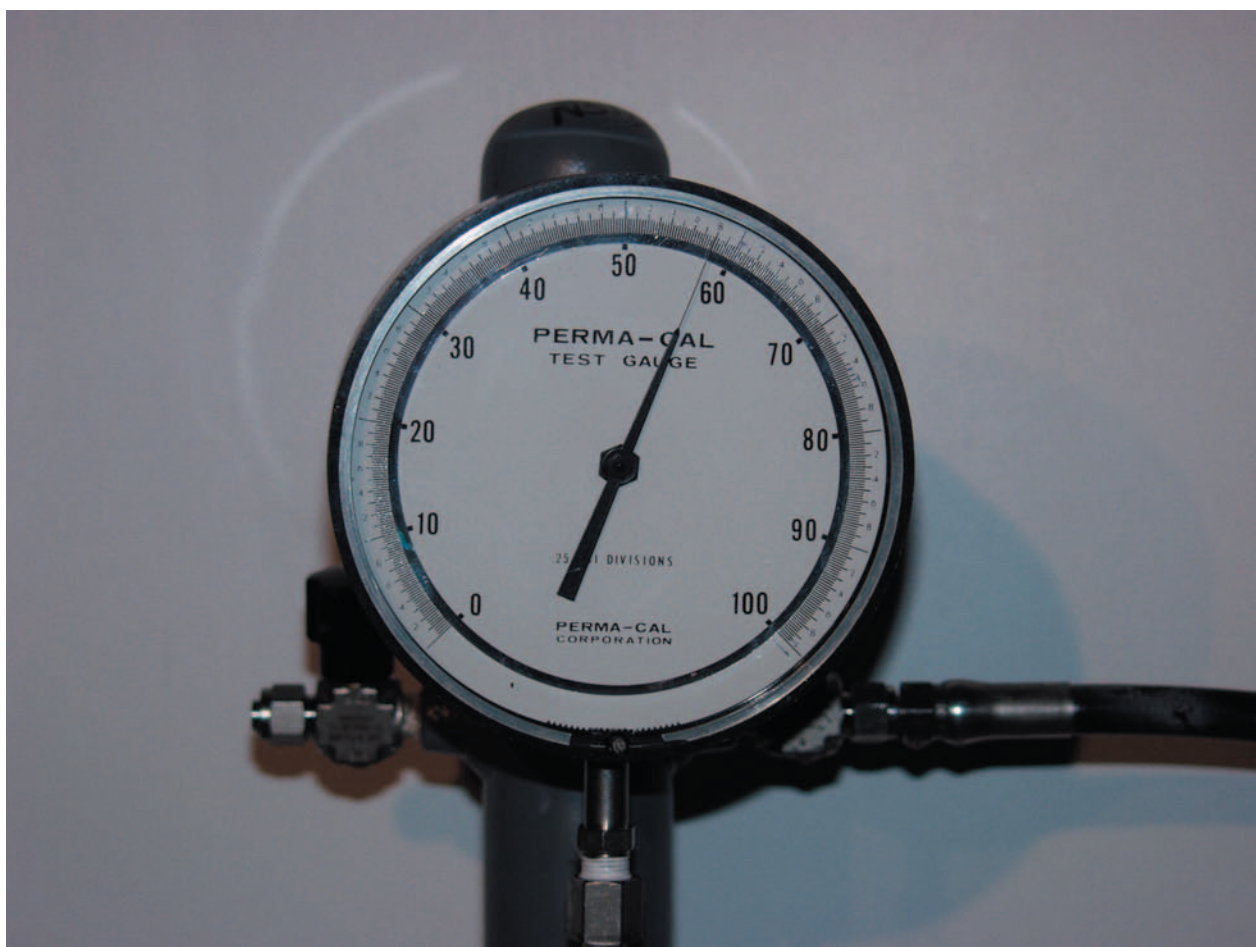
Exhibit 19

Photograph of test gauge showing a test pressure of 58#. The test gauge was installed on the riser to 66 Main Street, Hopkinton July 24, 2002

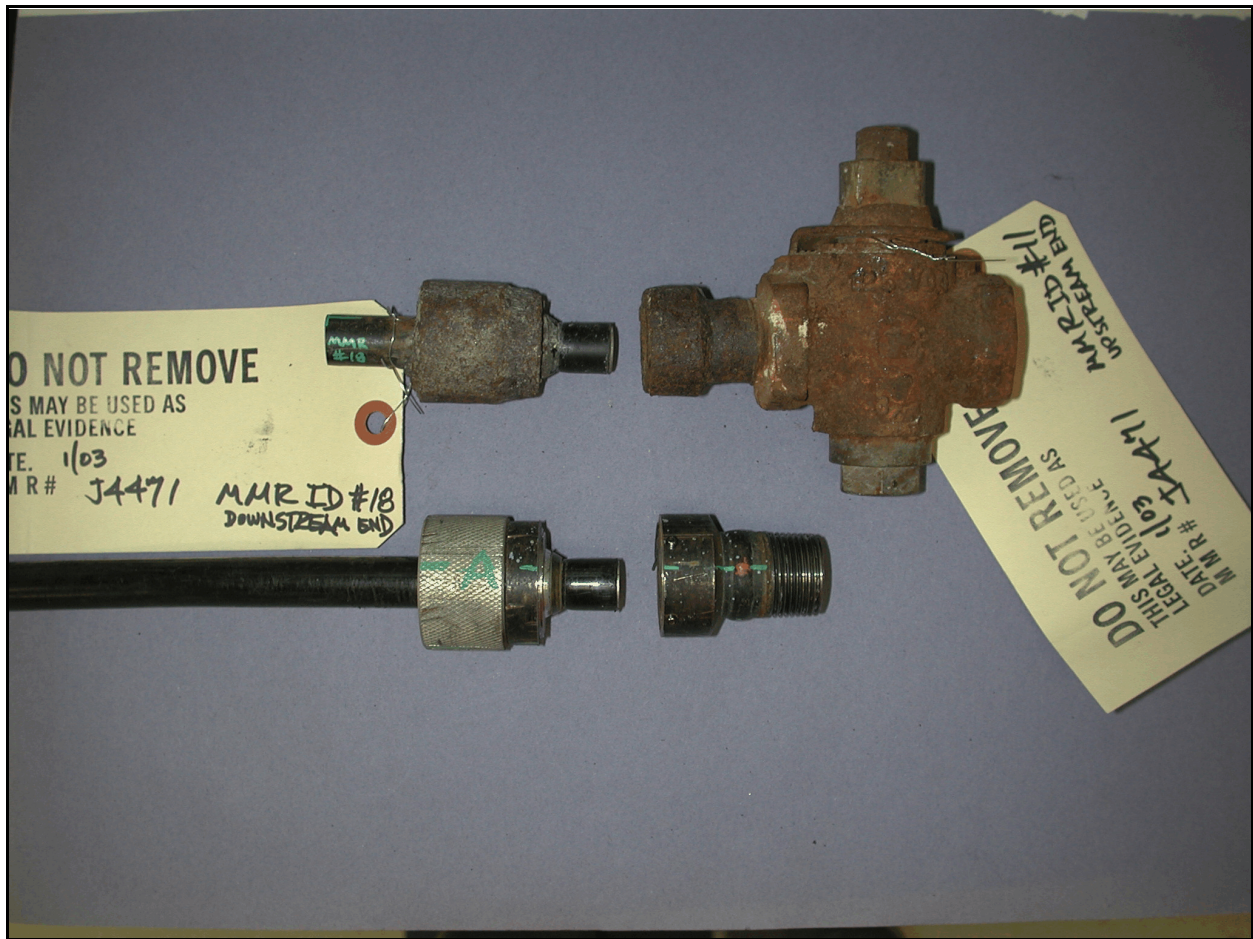
**Exhibit
31**

The MMR fracture analysis of recovered material indicates that the fractures occurred during the collapse of the building. A transition fitting³⁴ was located on the high pressure section of the service line.³⁵ The transition fitting was located just inside the basement wall prior to the explosion. It was found in two sections by SFM and DTE Investigators and documented by MMR as #18 (upstream segment) and #11 (downstream segment).³⁶ The fractured transition fitting is an adaptor (sometimes called a “basement adaptor”) for PE tubing of ¾-inch FPT x 1-inch MPT x ½-inch CTS, manufactured by Inner-Tite Corporation (Exhs. 31; 32).

The transition fitting displayed heavy corrosion around its outer surface. MMR describes this as “a friable³⁹ layer of corrosion.”⁴⁰ One of the water heaters in the basement displayed heavy corrosion around its base. The fieldstone foundation and dirt floor basement of the structure contained a sump pump. These conditions led MMR to state in its report “that the basement was a humid, and at times wet, environment.”⁴¹ MMR states that the corrosion may have been the result of aggressive chlorine attack since the orientation and amounts of chlorine were consistent with soil runoff as opposed to human handling and water residue from the fire fighting effort.⁴²

The transition fitting was found in two sections in the incident site debris, one of which was a part of MMR #11, and the other part of MMR #18. MMR conducted leak testing of the transition fitting in two stages. The downstream segment, MMR #11, was adapted for pressure testing at 57 psig. The test indicated only minuscule leakage on the valve attached to the transition fitting, but not on the transition fitting segment itself. MMR next inserted item #18 into item #11 as described in the MMR Report.⁴³ The threaded mechanical attachment between the upstream and downstream sections had degraded to a point where the two pieces were not fastened. MMR attempted to determine if the operating pressure would cause separation of the joined transition fitting parts. The pressure test revealed that the line pressure would not force the two segments of the transition fitting apart.⁴⁴ In conclusion, MMR states that the transition fitting came apart as the result of either the explosion/and or collapse of the house, or the application of an unknown external force or forces (not necessarily directly applied to the jurisdictional piping) prior to the event.⁴⁵

The MMR Report attributes the corroded state of the transition fitting to water contact. Although MMR did not determine that the failure of the transition fitting occurred prior to the explosion, DTE has reason to believe its corroded state presented a situation that should have

MMR photo of Inner-Tite transition fitting sections and
an intact exemplar of the same vintage.
65 Main Street, Hopkinton
July 24, 2002
